GD-GHEGS CORNER

The Mines and Geosciences Bureau Region VII Geosciences Division-Geohazard and Engineering Geology Section (MGB-7 GD-GHEGS) has conducted several activities in the first semester of 2021. In keeping with the mandate of mapping geologic hazards, the GHEGS Team conducted Vulnerability and Risk Assessment (VRA) and updating of the 1:10,000 scale geohazard maps in the Municipalities of Malabuyoc and Samboan in Cebu Province, as well as in Guindulman, in Bohol. Coastal Geohazard Mapping and Assessment (CGMA) was likewise undertaken in the Municipalities of Bantayan and Madridejos in Bantayan Island, Cebu. Outputs for these activities are Risk Exposure Maps (REMs) for the VRA, updated geohazard Maps and Shoreline Shift and Coastal Erosion Maps for the CGMA. These maps are useful tools for the Local Government Units (LGUs) concerned in formulating their Comprehensive Land Use Plans (CLUPs), Disaster Risk Reduction and Management (DRRM) and Contingency Plans as these maps indicate the susceptibilities of the LGUs to Rain-induced landslides and floods, and coastal flooding and erosion. Exit conferences were conducted in the VRA areas and IEC materials (posters and pamphlets

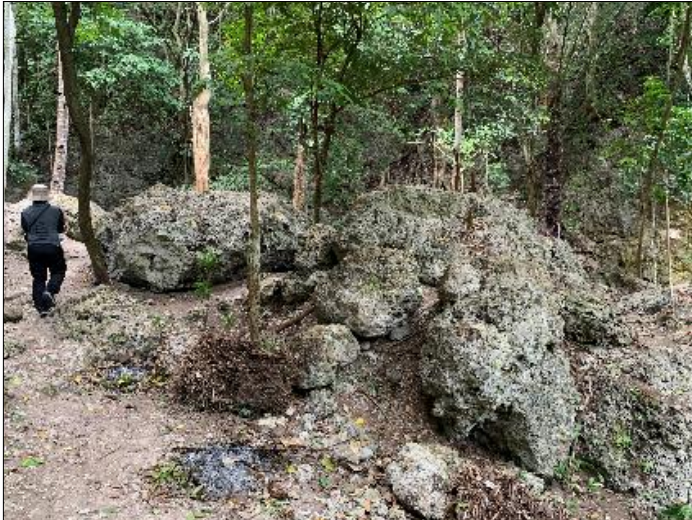
Highly weathered and oxidized Carcar limestone boulders along the river valley of Binlayan/Binalayan River in Purok Calin-ay, Barangay Poblacion, Samboan. These are rock fall debris from the very steep canyon walls bounding the river.

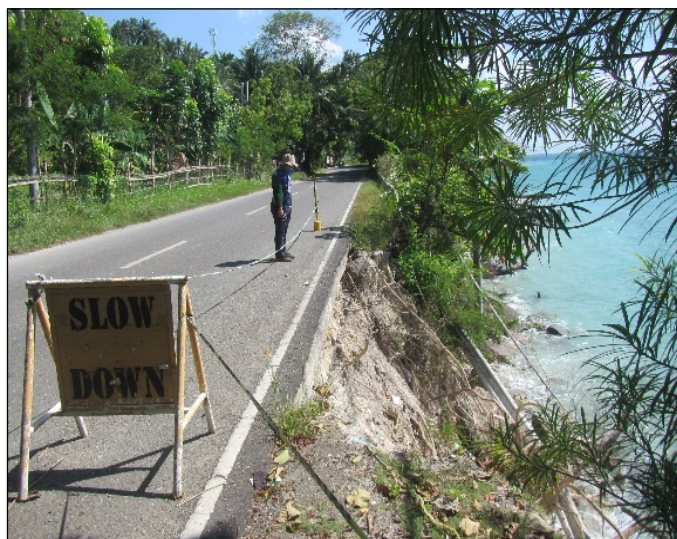
Wave action and erosion during typhoons caused the failure of the coastal slope at Sitio Butho, Barangay Armeña, Malabuyoc. There is a threat of road slip failure if the slope continues to be eroded/scoured. The road railing already collapsed into the sea.

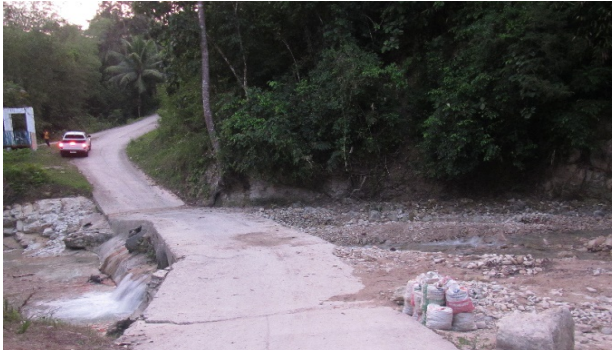
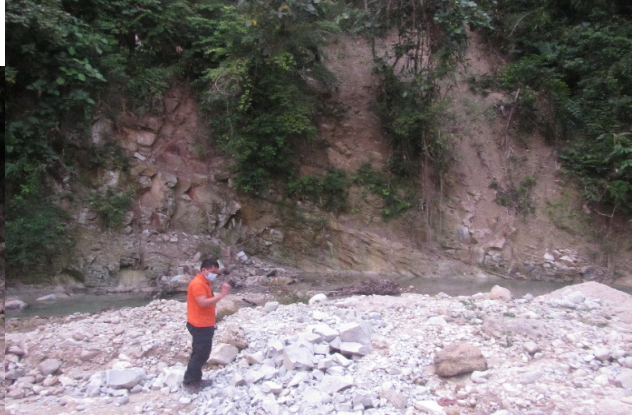
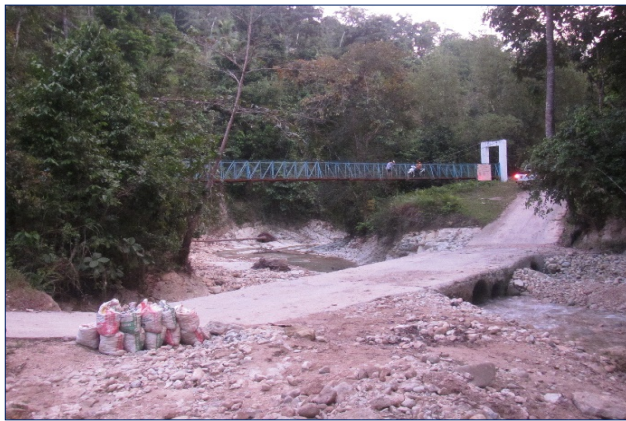
(9°41'14.5" N, 23°24'25.3"E)

This spillway crossing near the headwaters of Salering River (above and left photos) at Sitio Tibalao, Barangay Cerdeña, Malabuyoc, is highly susceptible to flooding whenever there is heavy rainfall in the area. Strong water flow causes scouring of the riverbank and affects the spillway approach. A steel footbridge (left photo) was constructed to enable crossing of residents during floods.

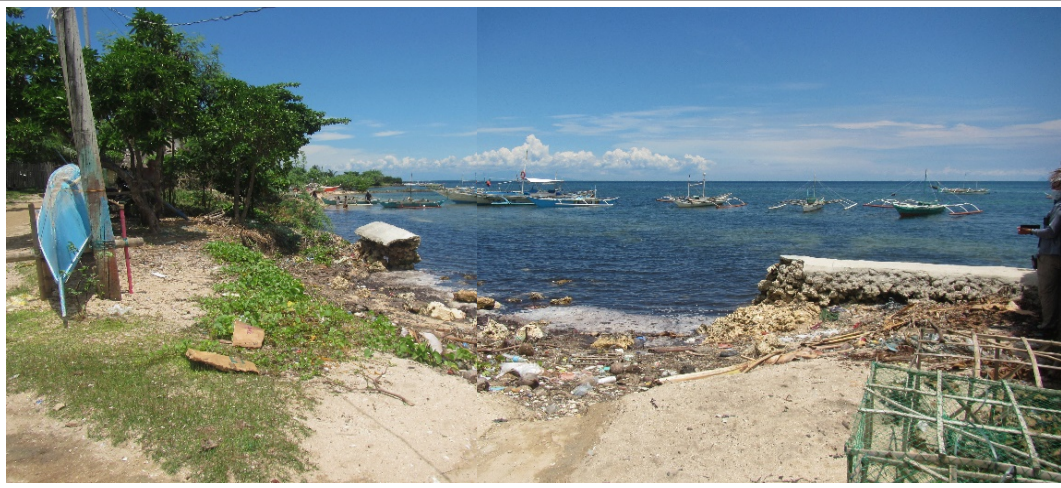
Damaged seawall at Purok Pluto, Barangay Patao, Bantayan, attests to the erosion potential of the area (above). Shoreline mapping and beach profiling at Purok Bangus, Barangay Sulangan, Bantayan reveals high erosion occurrence as exhibited by the exposed roots of the coconut trees lining the shore (left).
