KARST SUBSIDENCE HAZARD MAPPING AND ASSESSMENT IN THE MUNICIPALITY OF DALAGUETE, PROVINCE OF CEBU

SEPTEMBER 2021

REPORT ON THE KARST SUBSIDENCE HAZARD ASSESSMENT IN THE MUNICIPALITY OF DALAGUETE, PROVINCE OF CEBU

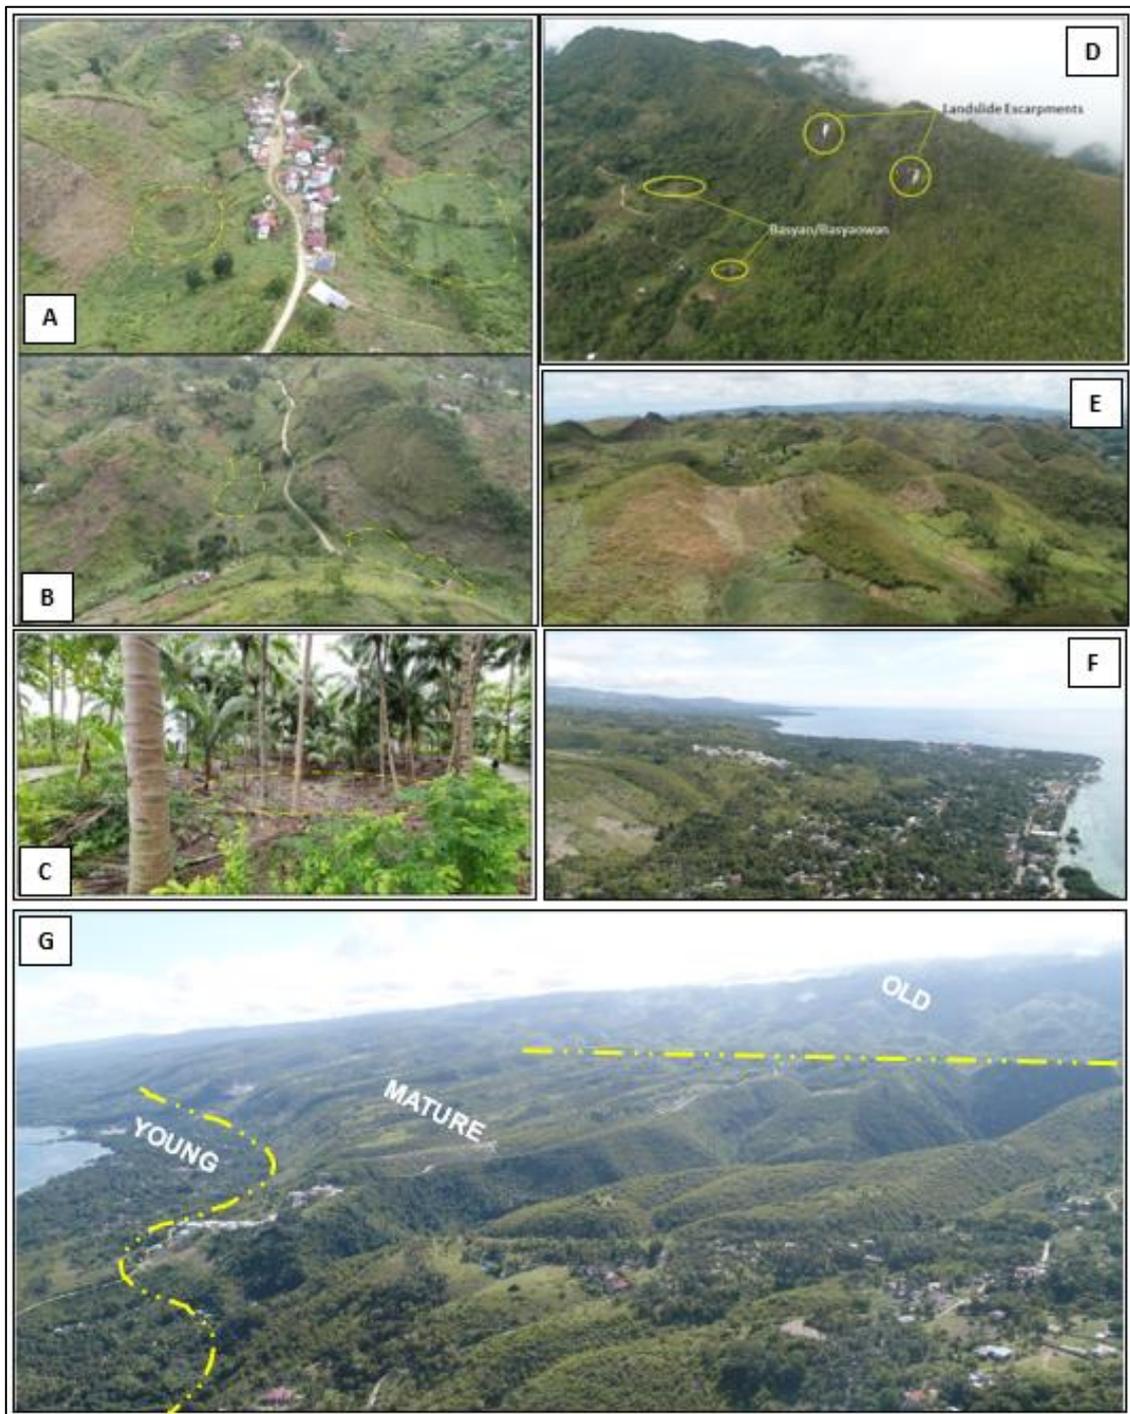
Photo 3-9 (A-B) Cover Subsidence Sinkhole (yellow outline) along natural waterway (dry river). (C) Cover Subsidence Sinkhole along a wide flat plain. (D) Fault controlled limestone ridge in Barangay Bulak. (E) Isolated hills (cockpit karst). (F) Sharp/abrupt topographic changes indicating periodical uplift (uplifted reef). (G) Unique terrain according to the maturity of limestone rock formations.

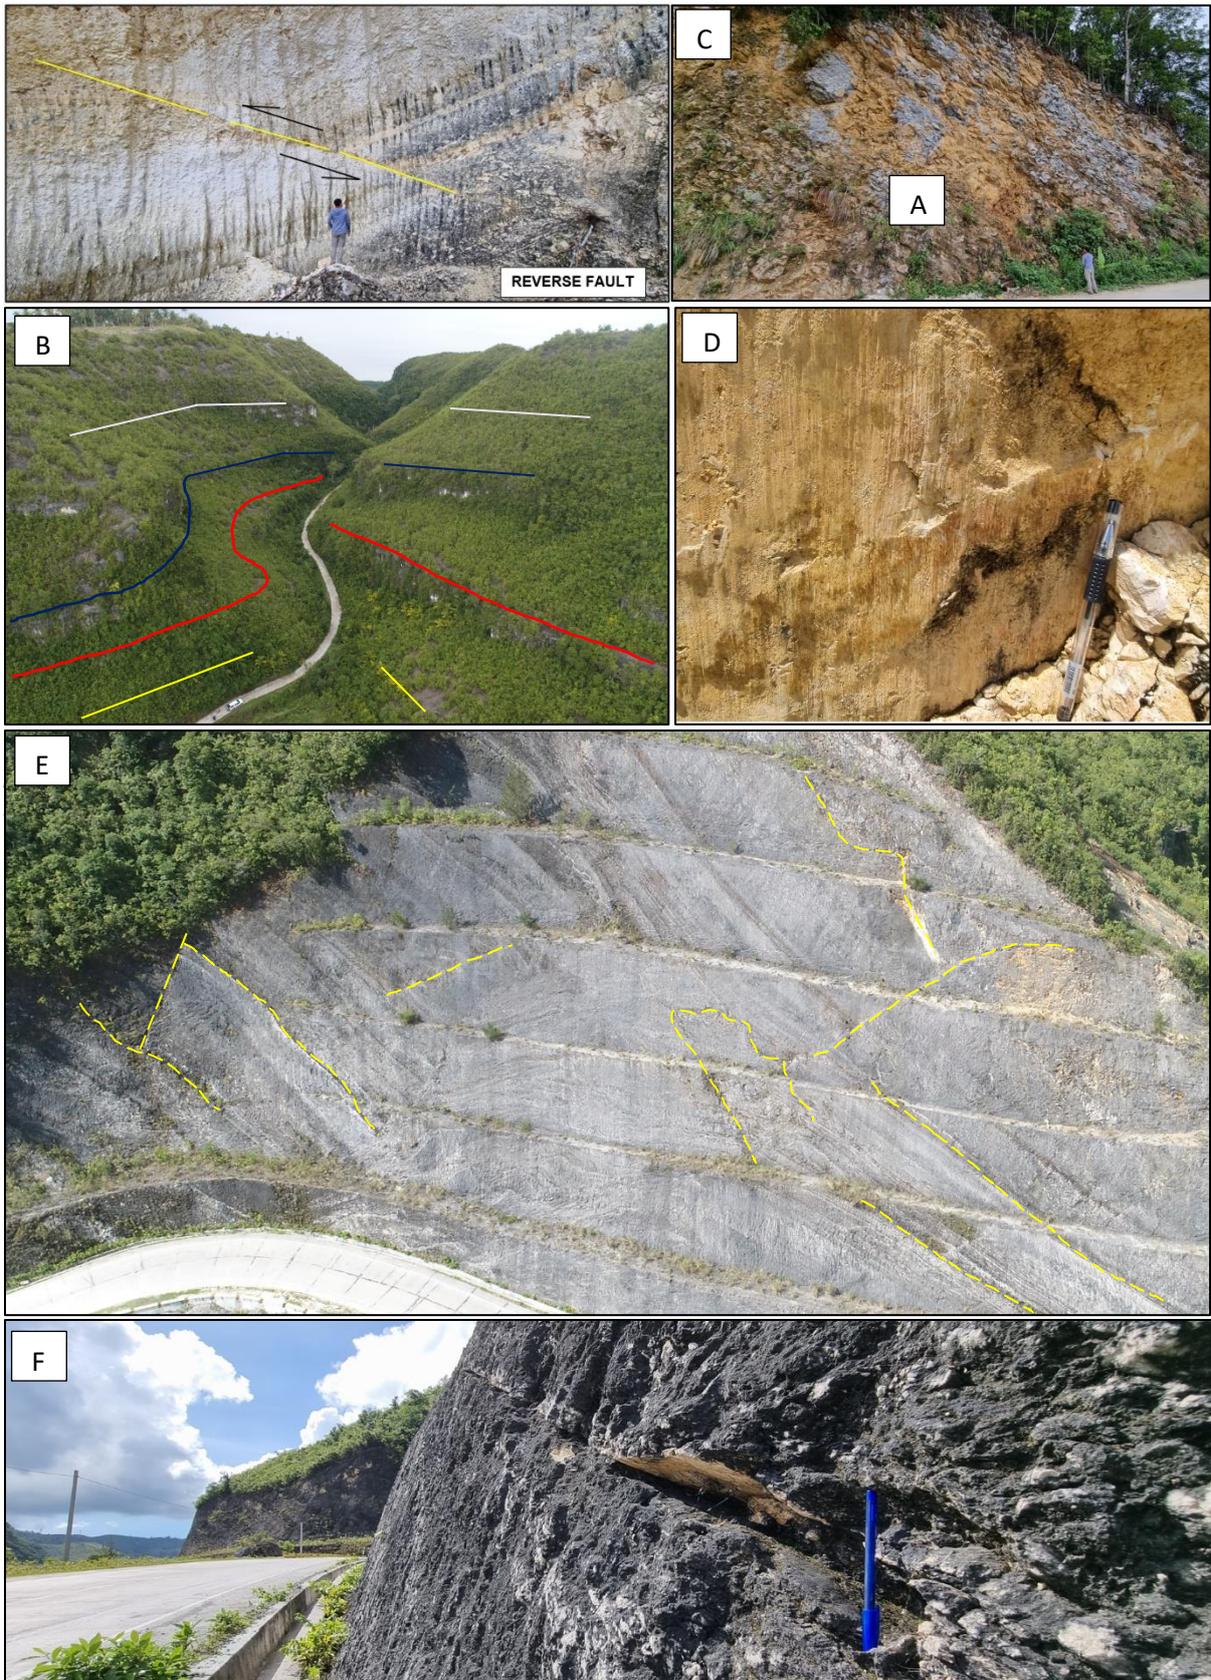
Photo 10-15 (A) Reverse fault along abandoned quarry in Lanao. (B) Periodic exposure of underground river/drainage (multi-level cave system) in Barangay Obong. (C) Highly fractured, well bedded limestone exposed along road in Barangay Ablayan. (D) Fault striations noted on an outcrop exposed in Barangay Dumalan. (E) Notable signs of an impending slope failure indicated by presence of numerous cracks along a road exposed in Sitio Paling-paling. (F) Closer view of one of the cracks noted in Sitio Paling-Paling.

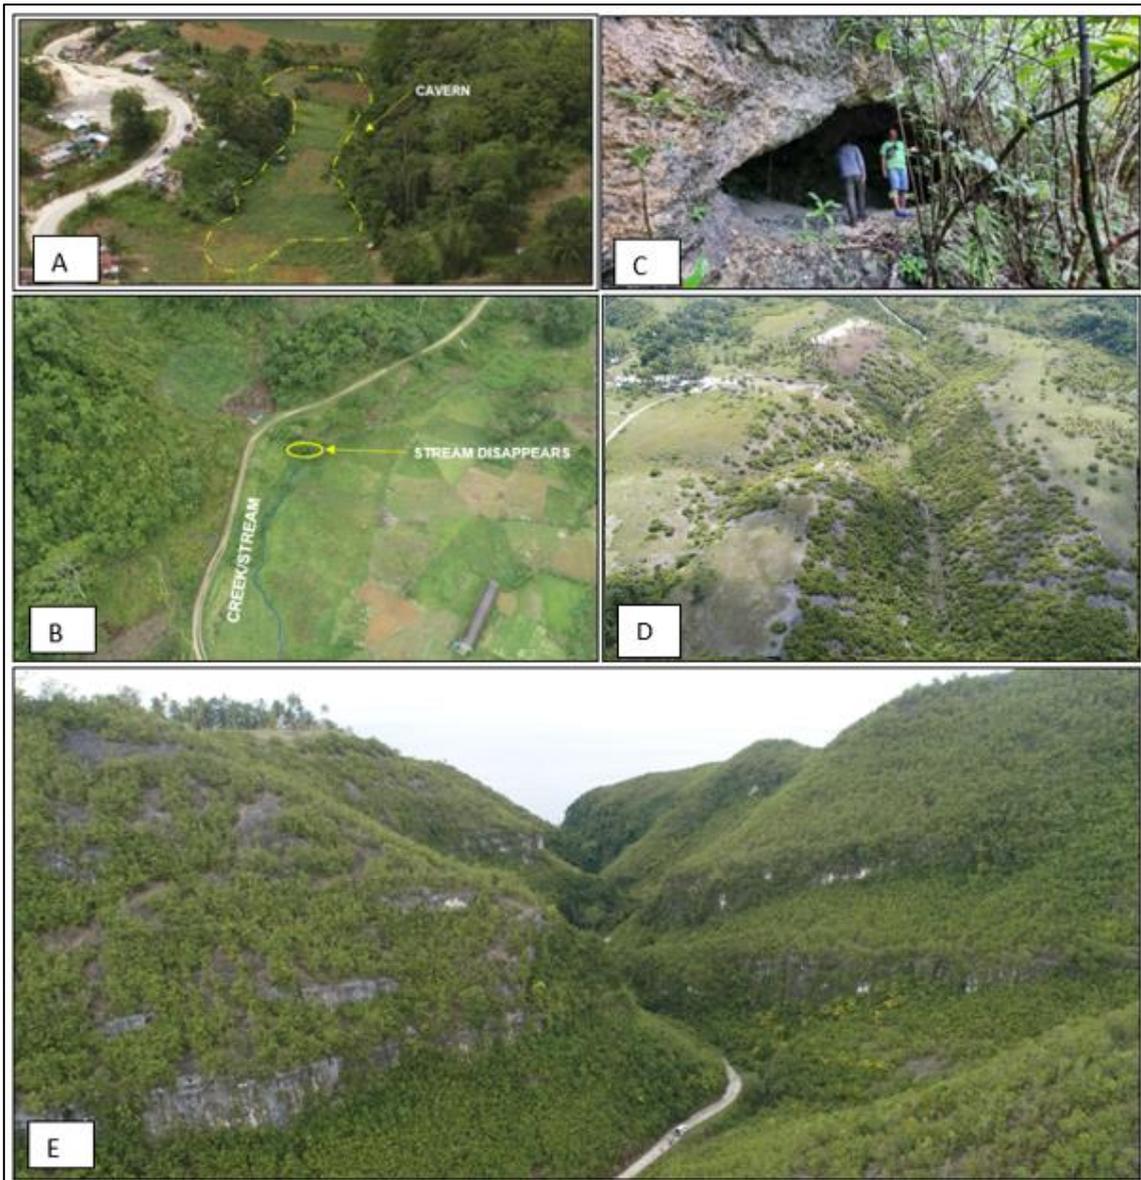
(A) Sinkhole along a natural waterway (streamsink) in Barangay Langkas. (B) Disappearing Stream in Barangay Nalhug. (C) Cavern along ridge slope in Barangay Banhigan. (D) Dry creeks and river IN Barangay Coro. (E) Marginal cliff indicating periodic collapse of subsurface drainage/underground river.

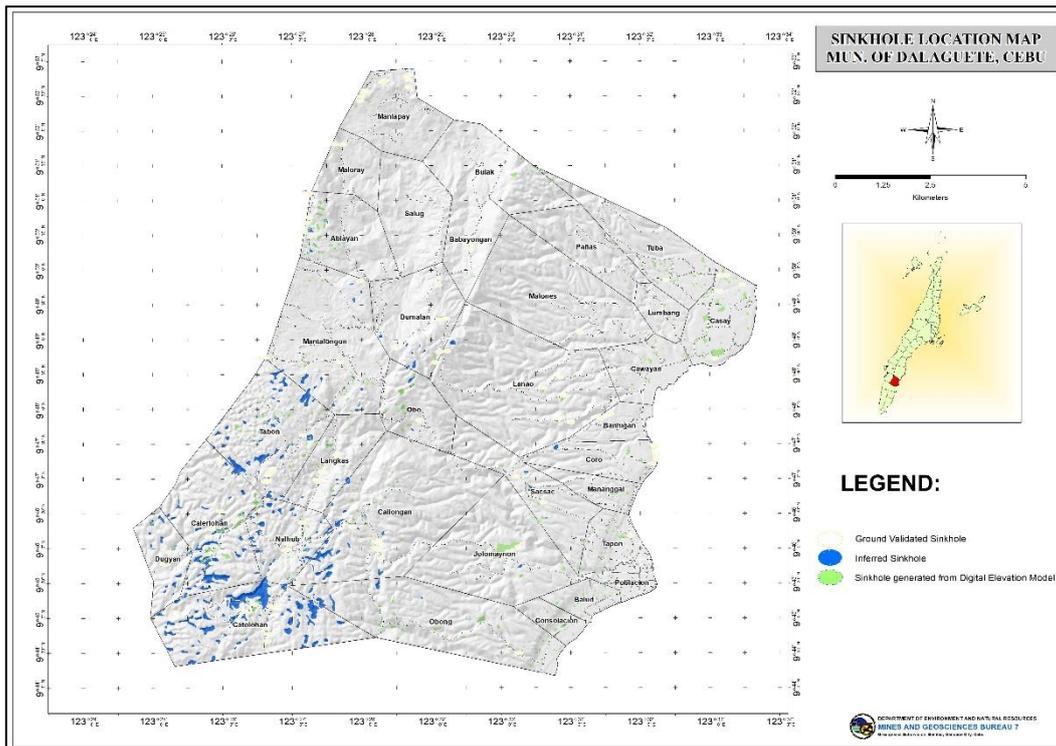
Plate 10. Sinkhole location and Distribution Map showing sinkholes delineated through actual ground validation, inference (geologic interpretations) and based on available NAMRIA Topographic Maps and IFSAR DEM Satellite Images.

- 2) Extra vigilance by residents during heavy, continuous rains brought by typhoon or monsoon rains, especially if areas with identified sinkholes are flooded. Divert run-off away from sinkholes. (Sinkhole Location Map).

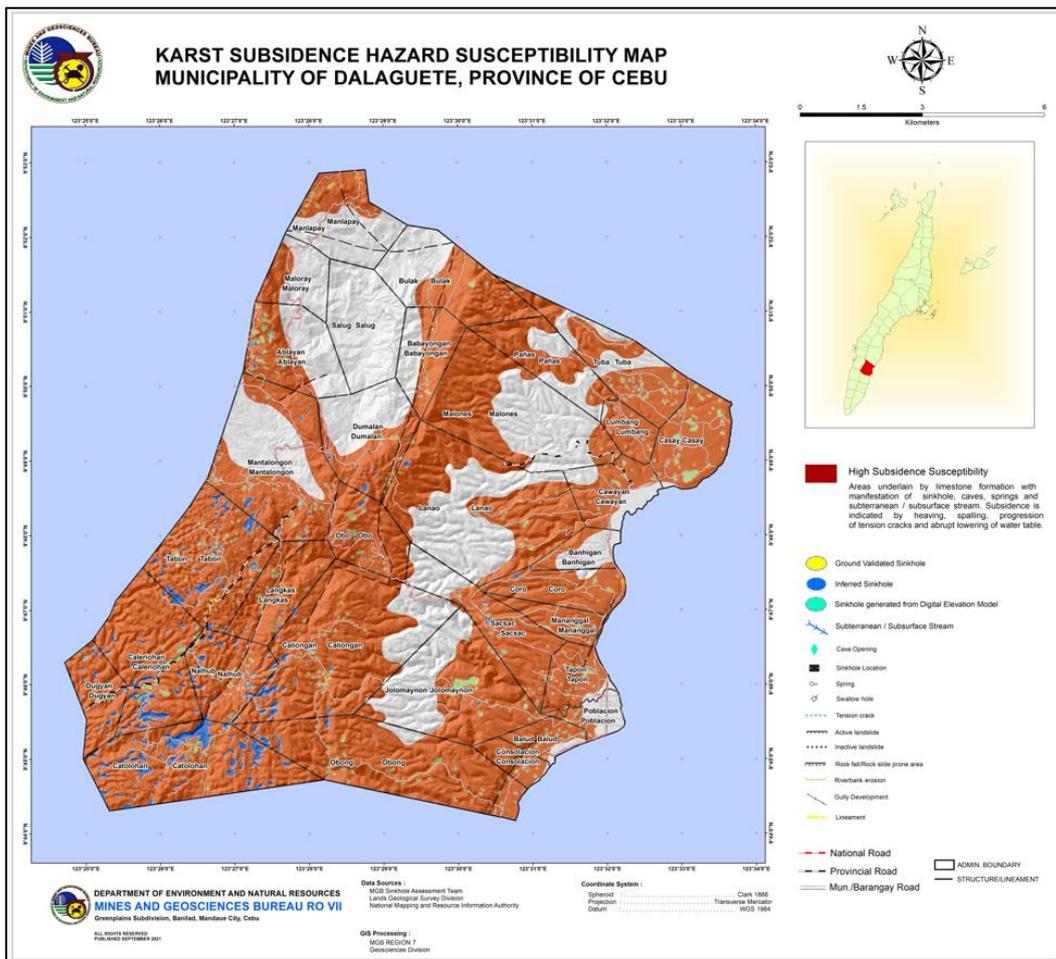
Plate 11. Karst Subsidence Susceptibility Map of Municipality of Dalaguete, Province of Cebu.

- 1) Vigilant monitoring of signs of sinkhole/cave collapse, and subsidence in the areas identified on the subsidence susceptibility map (Plate 9 and 10) by concerned barangay officials. Monitor presence of tension cracks that are widening and/or progressing, and circular ground depressions that are subsiding, especially every after heavy rainfall and flood events. Report the same immediately to municipal authorities/MDRRO.
