KARST SUBSIDENCE HAZARD MAPPING AND ASSESSMENT IN THE MUNICIPALITY OF DALAGUETE, PROVINCE OF CEBU

SEPTEMBER 2021

REPORT ON THE KARST SUBSIDENCE HAZARD ASSESSMENT IN THE MUNICIPALITY OF DALAGUETE, PROVINCE OF CEBU

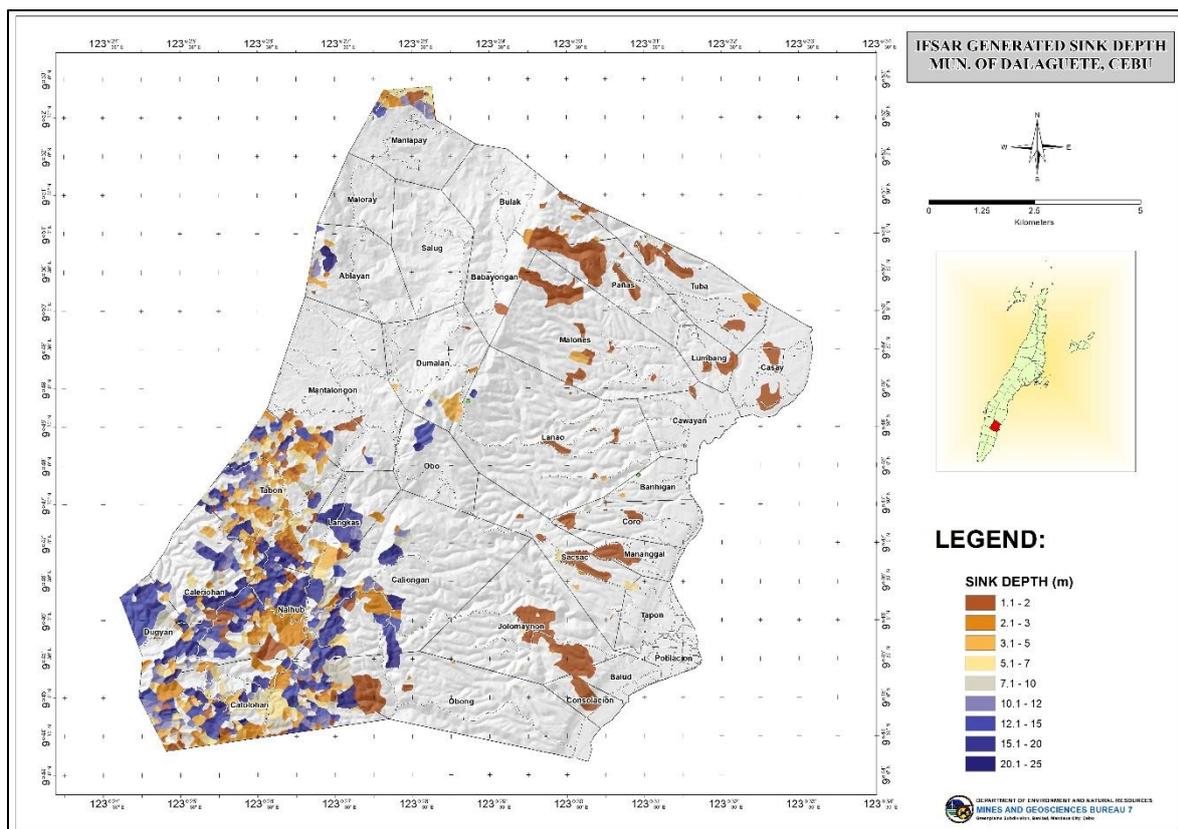
Plate 2. Sink depth Map generated by processing IfSAR-DEM images using ArcGIS Pro used as one of the primary base maps. Color variation represents depth of depressions and gives initial information on the relative location and distribution of the sinkholes and natural depressions within the study area.

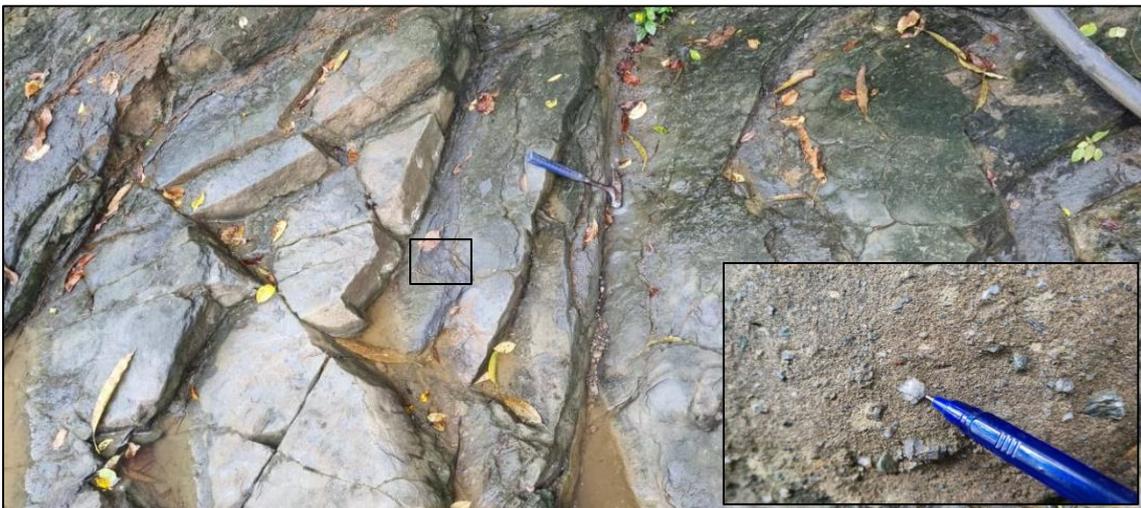
Well bedded clastic sequence exposed along the upper reaches of Argao River in Barangay Salug, Dalaguete.

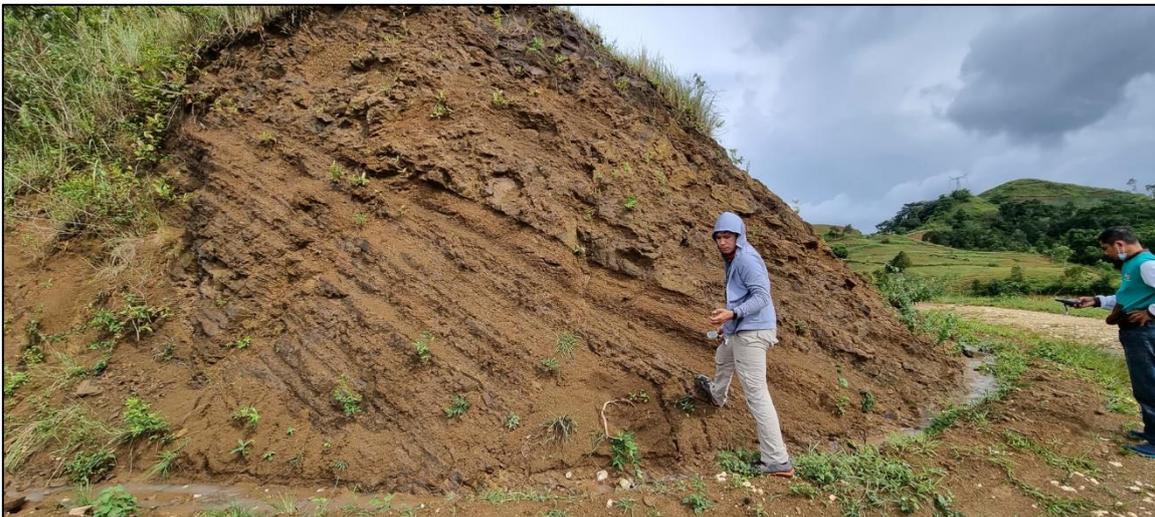
Highly weathered, highly oxidized carbonaceous clastic sequence exposed along barangay road in Barangay Babayongan, Dalaguete.

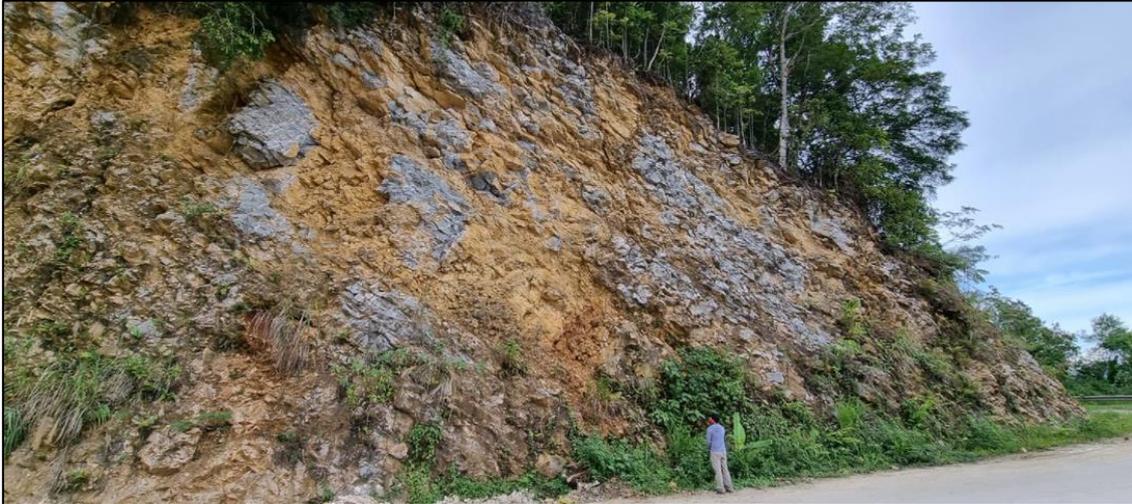
Massive to well bedded crystalline limestone exposed along road near the boundary between Barangay Dumalan and Ablayan. This formation forms a narrow prominent ridge extending along the boundaries of Mantalongon and Dumalan towards west of Ablayan and Maloray. The massive limestone occupying the Kandungaw Peak belongs to this formation.

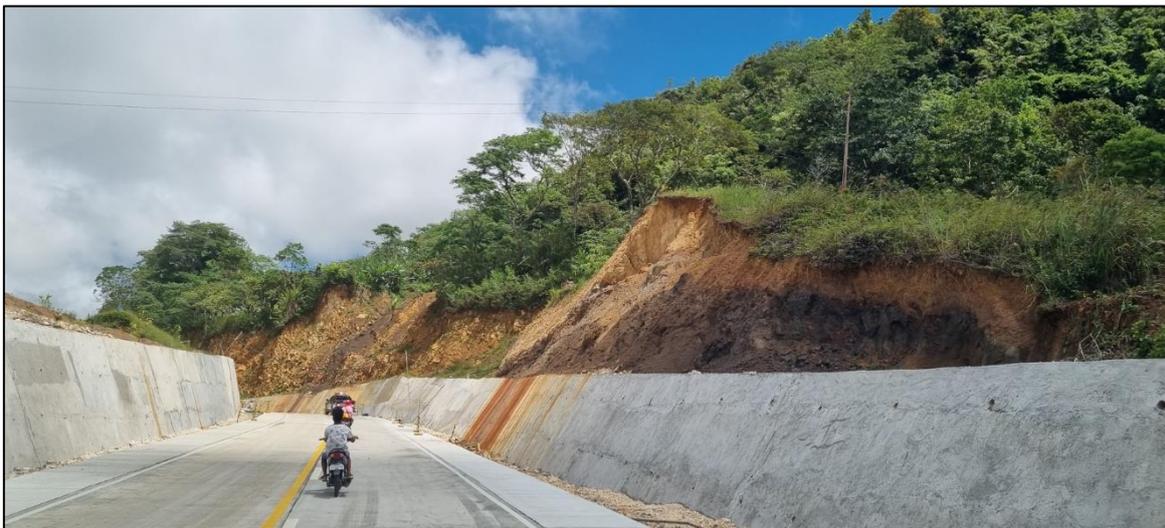
Clastic sequence with carbonaceous layer (dark brown) observed cropping out in Barangay Mantalongon along Dalaguete-Basac-Badian Road.

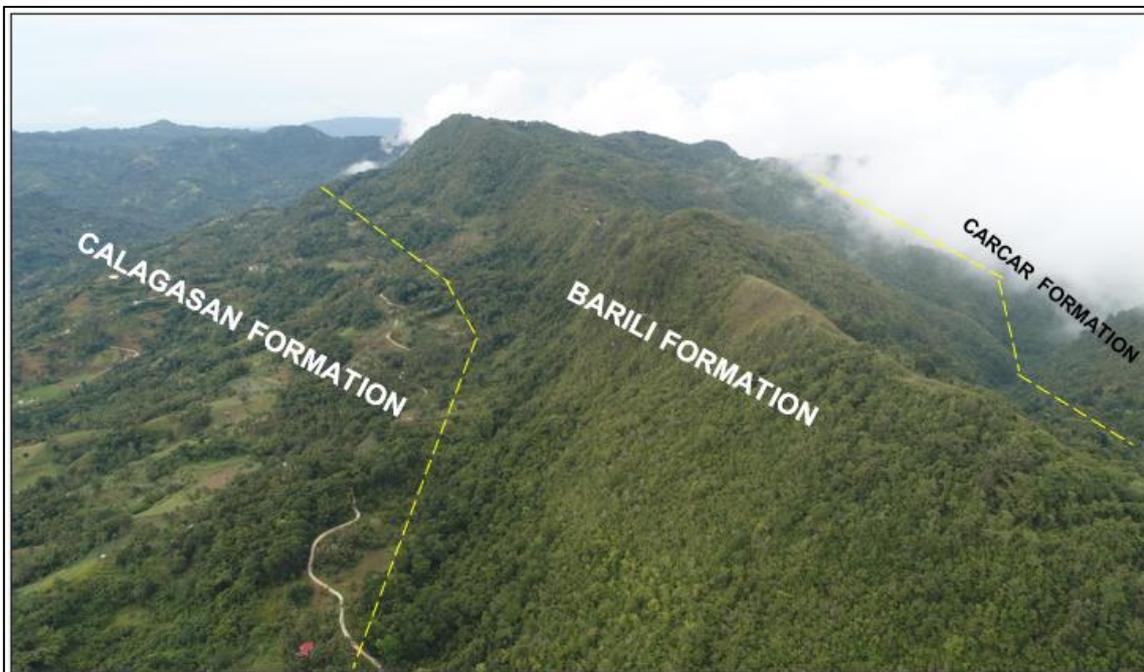
Barili Limestone formation observed to conspicuously towers as a long, narrow ridge in Barangay Bulak.

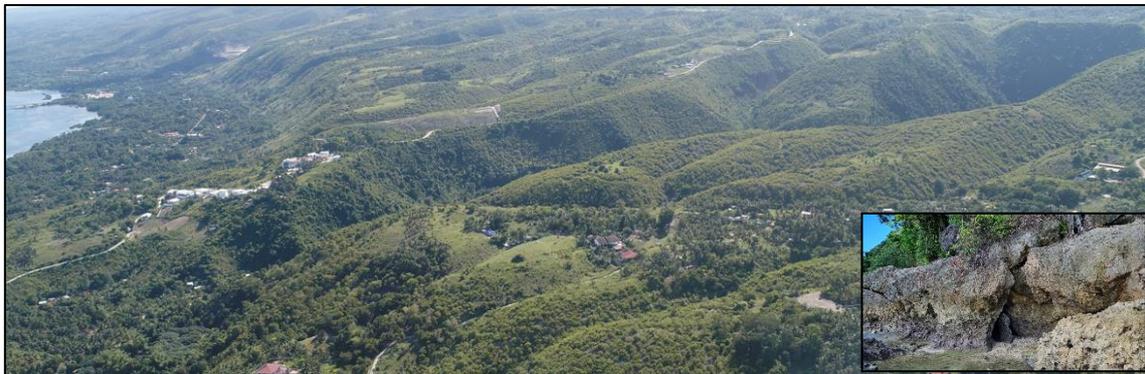
Uplifted coral reef fringing along the eastern part of the municipality is the Carcar Limestone Formation. (Inset) Cavernous coralline limestone exposed along a rocky coast in Barangay Coro.

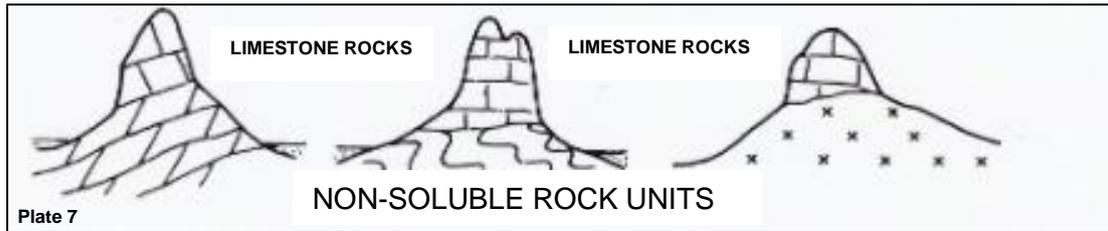
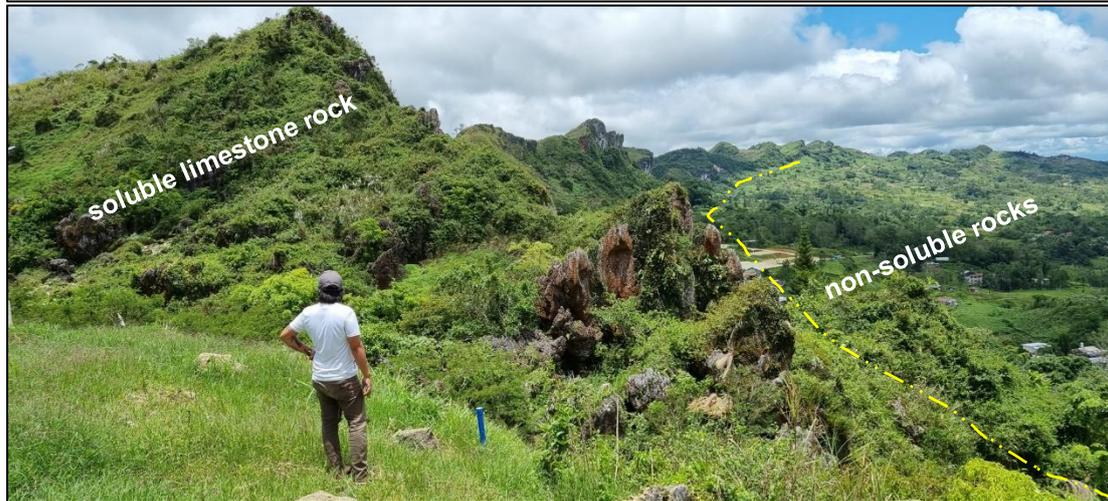
Rock disparities displaying different terrains. Soluble rock formation (Barili Limestone Formation) forming karst towers and limestone cliffs overlying a non-soluble rock (clastic sequence of Linut-od Formation) in Barangay Mantalongon. Relative boundary/contact between the two rock formations is indicated by yellow dashed line.

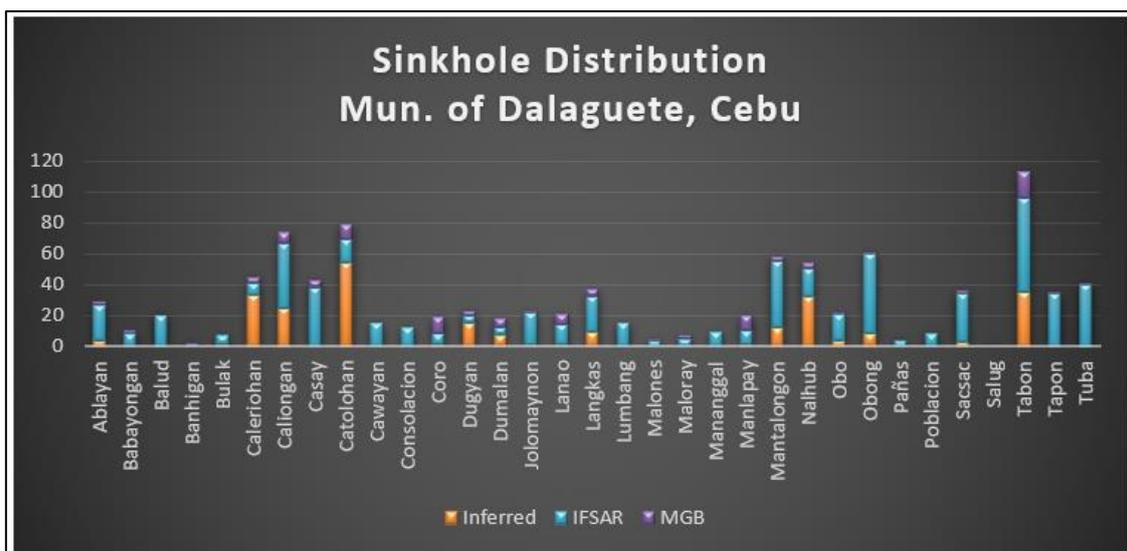
Plate 9. Graphical presentation of Ground validated, Inferred and Sinkholes Based on Satellite Images and Maps delineated in each barangay.

- 1) Vigilant monitoring of signs of sinkhole/cave collapse, and subsidence in the areas identified on the subsidence susceptibility map (Plate 9 and 10) by concerned barangay officials. Monitor presence of tension cracks that are widening and/or progressing, and circular ground depressions that are subsiding, especially every after heavy rainfall and flood events. Report the same immediately to municipal authorities/MDRRO.
